# Technical Bulletin

## *IZIP E3 DASH*

### *Bottom Bracket Adjustment*

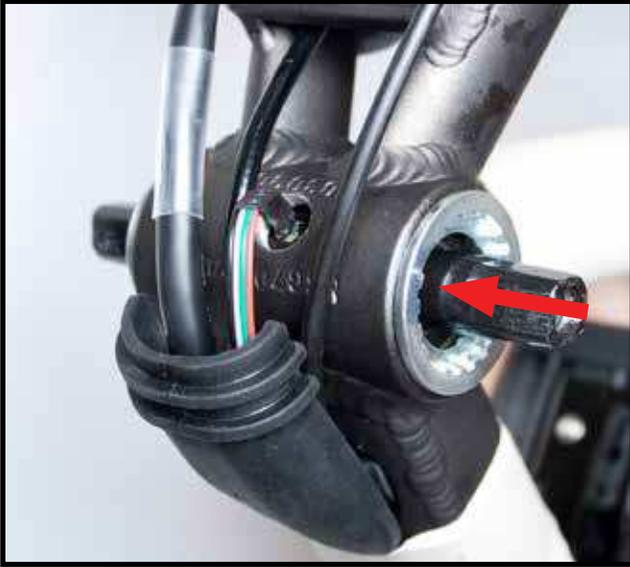
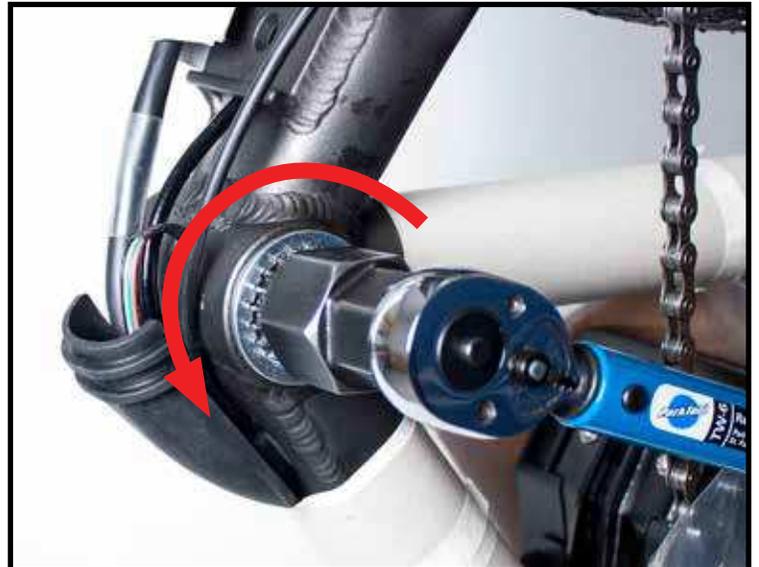
#### Step 4:

**ATTENTION:** The bottom bracket cups may be loose! This may allow the bottom bracket sensor to rotate within the shell and result in damaged wires and intermittent or no assist.

Gently tap the bottom bracket spindle toward the left to free it from the right side cup. Then using a torque wrench and the Shimano bottom bracket tool, tighten the drive side bottom bracket cup to 60Nm (44 ft-lb).

**\*NOTE:** Drive side cup is reverse threaded. To tighten, turn counter-clockwise.
