Technical Bulletin

IZIP E3 DASH AND PATH+ Rear Hub Motor

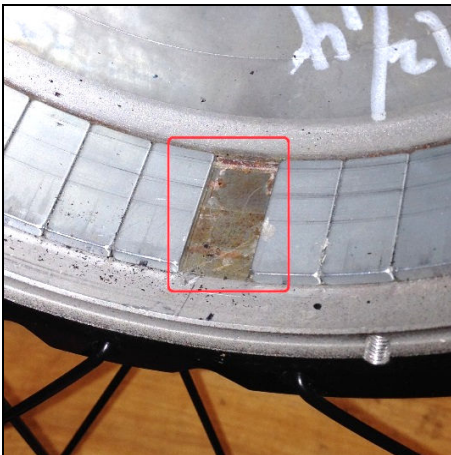
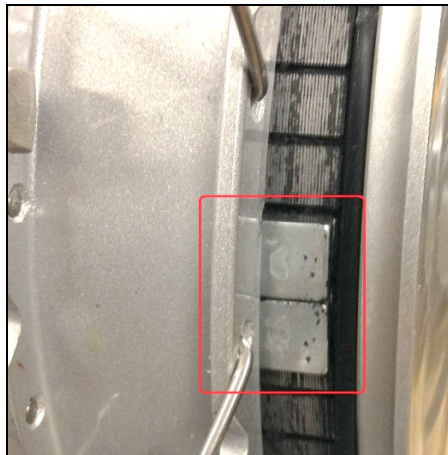
Magnet bonding adhesive failure

- An abnormal clicking or grinding noise emanating from the rear Hub Motor during rear wheel rotation
- Amplified pedaling resistance beyond what is normal for an electric Hub Motor

Failure Examples – Magnet(s) can come loose and adhere itself to the stator causing either clicking and/or increased resistance.

Our supplier has already made improvements to future production by using a stronger bonding agent for magnet assembly. Currie Tech is prepared to supply you with a new complete replacement wheel if you were to experience this failure. There is no need for you to disassemble the Hub Motor and prove loose magnet if you believe this issue exists on your bike, simply call in to our Customer Service Department at [1-800-377-4532](tel:1-800-377-4532)
